FIELD SAFETY NOTICE

Recommendation to implement Exelia software version 1.2.3

Subject: Field Safety Notice regarding new Exelia software version 1.2.3

Affected Products: Exelia SP; Exelia VP; Exelia Combox; Exelia Therapy Manager

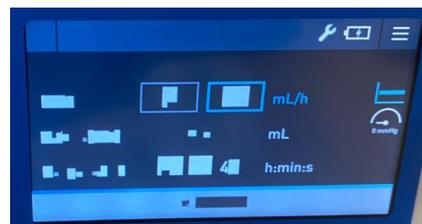
The software may suddenly display two different screens alternately (e.g., syringe installation screen and home screen) or prevent a value from being set.

It could also happen that the values suddenly become unreadable, or appear frozen for several seconds or even minutes. The infusion continues normally.

Inability to program the infusion. If an infusion is in progress, it is necessary to transfer the infusion to another device and then turn off the device. In the worst-case scenario, a technical error 16.18.39 could occur with a potential infusion stop.

Display of 2 or 3 screens alternating unexpectedly and/or Altered display of texts and values and/or frozen screen.

If the event occurs, transfer the infusion to another device, then press the ON/OFF button until the module turns off, i.e. for 3 seconds or for 20 seconds if the switch-off is not effective in 3 seconds. Then turn the module back on and it can continue to be used if no fault is reported when it is re-ignited.

Upgrade all your Exelia devices to the latest software version "Exelia 1.2.3".
