URGENT Field Safety Notice

Wired Avalon Ultrasound Transducer (product number 867246)
Inaccurate Fetal Heart Rate (FHR) measurements when monitoring multiples

22-MAY-2024

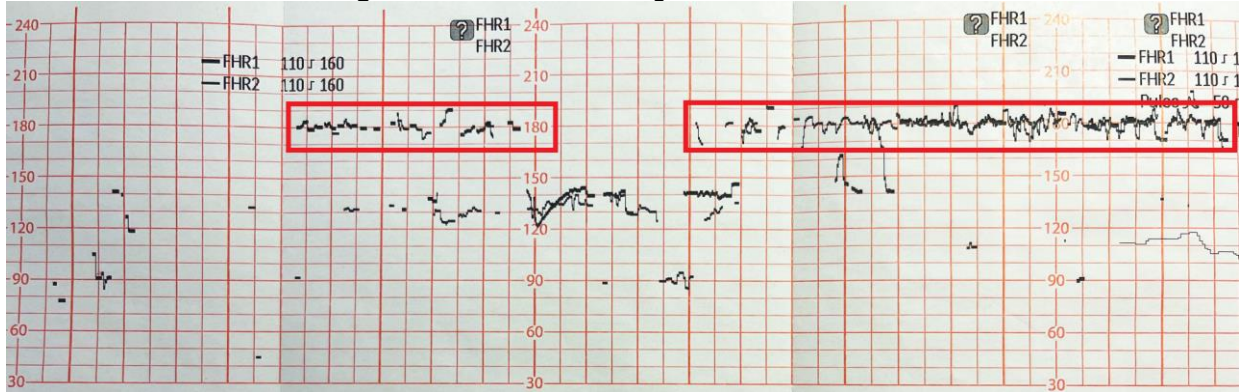
Figure 1. FHR Trace During Occurrence of Issue

It was found that the latest version of the wired Avalon Ultrasound Transducers (867246) may report inaccurate Fetal Heart Rate (FHR) measurements when monitoring multiples (twins or triplets): In situations where the physiological signal (echo from the fetal heart) is absent or very weak (e.g. in early weeks of pregnancy), there is a tendency of the wired Ultrasound transducers to interfere with each other and subsequently to produce an artificial FHR, mostly at approximately 180 bpm. The use cases affected by this issue are twin or triplet monitoring with wired Ultrasound Transducers including at least one transducer with software version L.01.04. The population at risk is women with multiple gestation (twins/triplets).

Figure 1 below shows an example trace of FHR measurements when this issue occurs. Highlighted in red are the sections of the trace which show the issue as it would be present for the clinical user.

1. The affected Avalon wired transducer with software revision L.01.04 must not be used when monitoring multiples.
2. The Avalon wired Transducer 867246 can be safely used in the following cases:
 - a. Monitoring the FHR of singletons (ca. 97% of all pregnancies) with any wired Avalon Ultrasound Transducers, including 867246 Ultrasound Transducer with software revision L.01.04.
 - b. Monitoring also of twins or triplets with wired Ultrasound Transducers, as long as none of the involved transducers is an 867246 Ultrasound Transducer with software revision L.01.04.
