## **Safety Advisory Notice**

To all affected users of the SIEMENS systems  
Luminos Agile Max, Luminos dRF Max, LUMINOS  
Lotus Max with display ceiling suspension and  
Multitom Rax with display wall suspension

## **Re: Potential risk of unintentional lowering of the support arm for display ceiling suspension / display wall suspension**

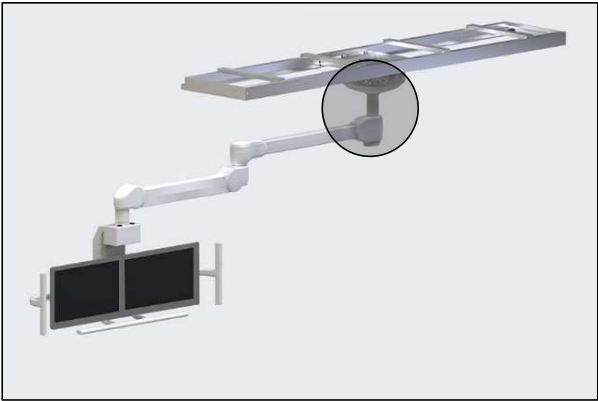
Please visually inspect the mounting screw on the ceiling tube (Figure 1) or wall tube (Figure 2) of the display suspension as far as this is possible from the ground.

Figure 1 Display ceiling suspension with ceiling tube circled

If the mounting screw is missing, or if the screw head protrudes or is broken, discontinue use of the system immediately. Please inform the Siemens Healthineers customer service. Furthermore, if the display ceiling/wall suspension has lowered, discontinue use of the system immediately and inform customer service of the issue.

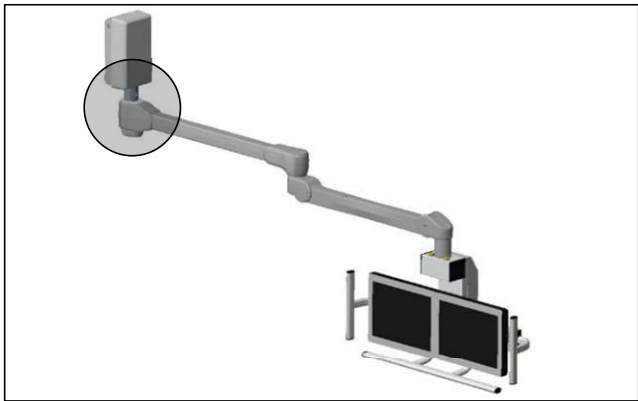
Figure 2 Display wall suspension with wall tube circled

For display wall suspension: The tube attachment on the wall suspension is identical to the tube attachment on the display ceiling suspension.

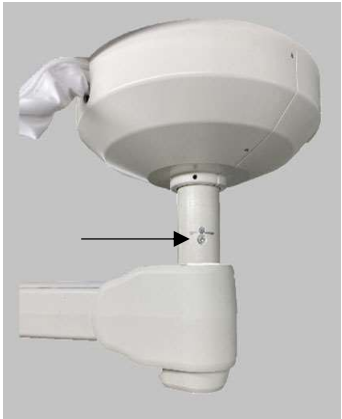
Exemplary illustration of mounting screw and tube attachment on the display ceiling suspension showing the correct (figure 3) versus incorrect (figure 4) tube attachment:

Figure 3 Correct: Mounting screw available and no visible damage

In case the visual inspection of the mounting screw does not show any abnormalities, you can continue to use the system. Nevertheless, until the system has been checked by Siemens Healthineers customer service with the planned field action, we recommend:

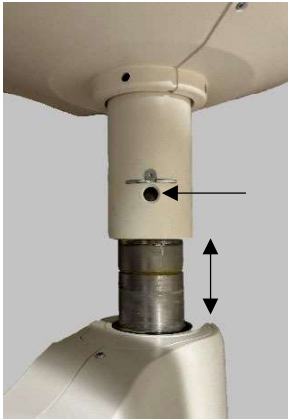
There is a potential risk that the mounting screw on the support of the display ceiling/wall suspension may loosen or be missing, causing the support arm with displays to lower downwards with continued use. In a worst-case scenario, the support arm could lower suddenly and cause serious injury. During service activities Siemens Healthineers XP became aware of two cases in which the mounting screw was missing. No injuries were associated.

Figure 4 Incorrect: Mounting screw missing and/or lowered support arm
