For all users of mint Lesion™ versions 3.9.0, 3.9.1, 3.9.2, 3.9.3, 3.9.4, 3.9.5, 3.10.0 and 3.10.1

2024-11-13

Urgent Field Safety Notice

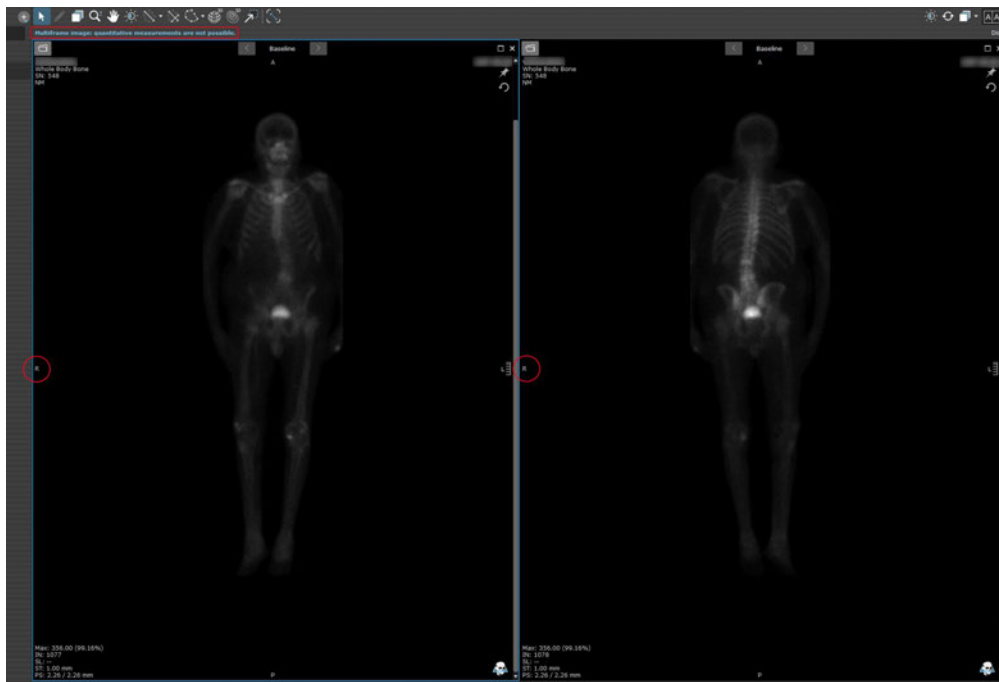
mint Lesion™ shows patient orientation markers (L,R,A,P,H,F) for each image in a DICOM series. They describe how the patient is positioned in the image. When the malfunction occurs, these orientation markers may be wrong. For example, the left (L) and right (R) markers may be transposed (see Figures 1 and 2). If not noticed, this could lead to a user assuming a wrong anatomical location of a finding.

Figure 1: Whole-body bone-scan images with two projections. The left/right (L/R) orientation markers in the left anterior projection are correct while the L/R orientation markers in the right posterior projection are transposed.

Verify the patient orientation based on anatomical landmarks that you can see in the images, when you rely on patient orientation for reporting findings (e.g., "anomaly in left kidney").

The error will be corrected with a software update. Mint Medical Support will contact you when the update is available to schedule the installation of the update on your system.

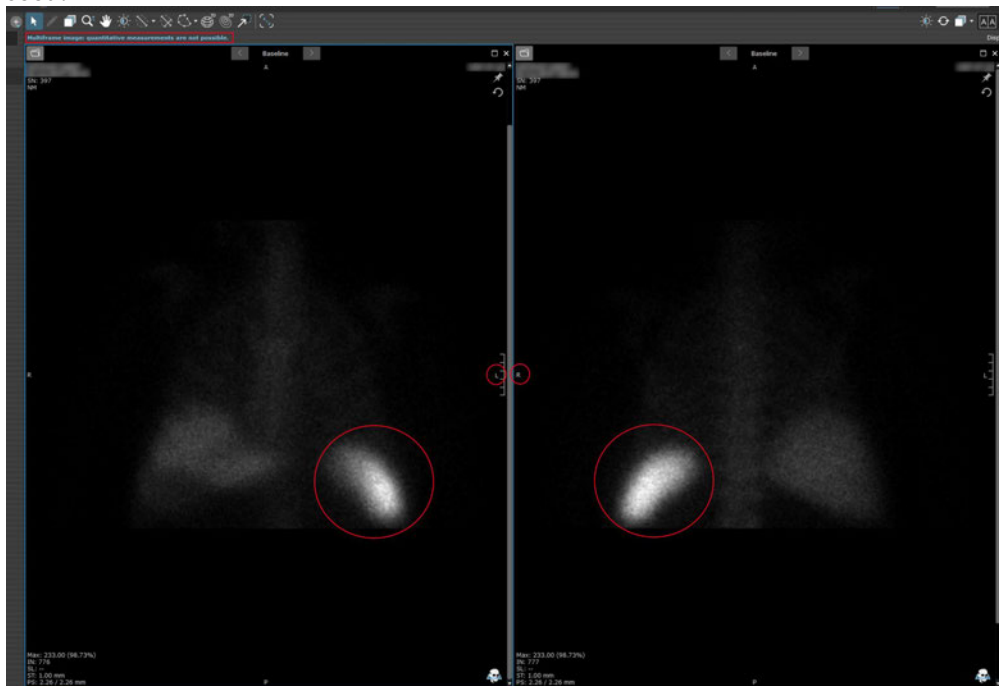
Figure 2: Chest bone-scan images with two projections. The L/R orientation markers in the left projection are correct while the ones in the right projection are transposed.
