URGENT MEDICAL DEVICE CORRECTION

Model 1000 SenTiva[™] and Model 1000-D SenTiva Duo[™] VNS Therapy[™] Generators

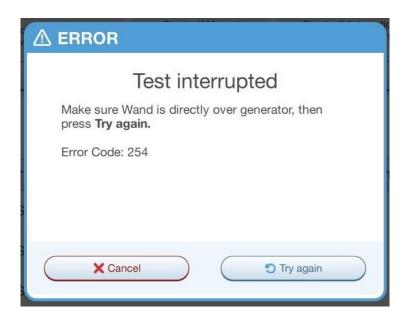
For all generators, perform an on-demand System Diagnostic test (using the Diagnostics tab in the programming software) at every clinic visit to confirm proper function of the generator. A generator with a reed switch stuck in the closed position will display "Error Code 254 – Test Interrupted" on a Model 3000 programmer when a diagnostic test is attempted using the VNS Therapy Programming System (see Figure 1).

Figure 1: "Error Code 254 – Test Interrupted" message encountered during System Diagnostic Testing

- Contact LivaNova Customer Quality by phone at +1-281-228-7330 or by e-mail at <u>cservices@livanova.com</u> if communication with the generator using the VNS Therapy Programming System indicates that:

- i. Diagnostic tests cannot be performed ("Error Code 254 Test Interrupted" error message)
 - ii. Programming changes cannot be made ("Error Code 254 Apply Changes Interrupted" error message); or

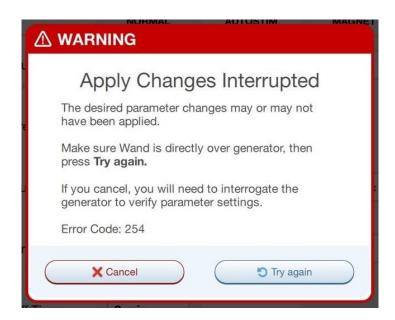
A generator with a reed switch stuck in the closed position may also prevent parameter changes from being made with the programming system. The programmer may display "Error Code 254 – Apply Changes Interrupted" (see Figure 2).

Figure 2: "Error Code 254 – Apply Changes Interrupted" message encountered during programming

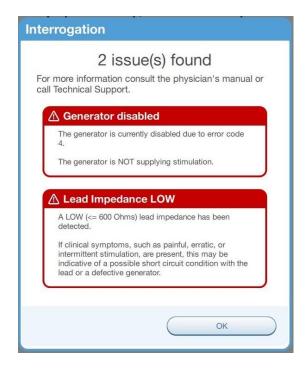
An on-demand System Diagnostic test may result in LOW lead impedance for some generators with a reed switch stuck in the closed position (see Figure 3).

Figure 3: Low lead impedance error message

- iii. System Diagnostic test displays a "LOW" lead impedance result.
- 3. Encourage patients to do the following:
 - i. Notify you if they perceive a change in clinical symptoms (e.g., increase in seizures or depressive symptoms).
