## Urgent Field Safety Notice (FSN)

Replacing the power supply unit  
for care beds in the Ecofit range

23.04.2024

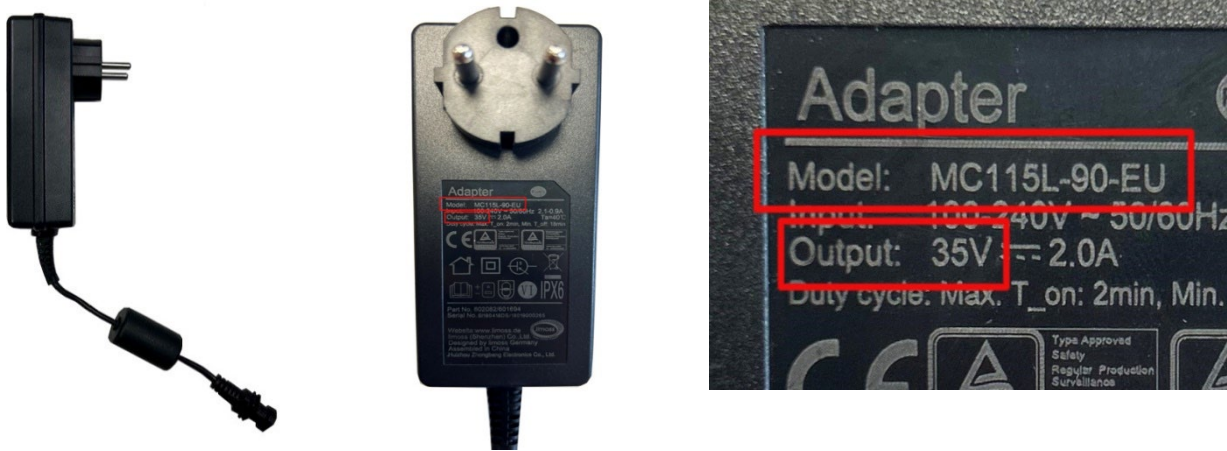
This only applies to Ecofit care beds with the built-in power supply unit **MC 115L-90-EU** (manufacturer limoss GmbH) and an output voltage of **35V**. The attached list shows the serial numbers of all products (see cover sheet) for which the power supply unit needs to be replaced.

Please replace the MC115L-90-EU power supply unit with the PS1102 power supply unit provided free of charge by tecfor care for care beds from the Ecofit range in your inventory or during the next maintenance. Instructions for replacement can be found in the appendix to this letter.

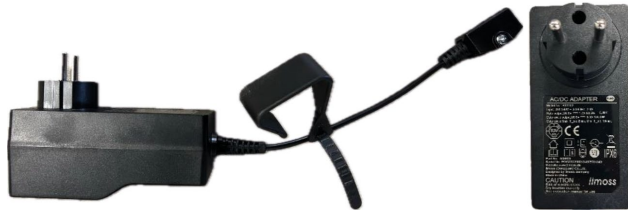
**ANNEX:****Instructions: Replacing the power supply unit**Scope of delivery:

Description:

**Plug-in power supply SMPS - PS1102**  
200-240V, 50-60Hz, 2,4A, IPX6  
Model number: 503605
