Urgent Field Safety Notice (FSN)

Replacing the power supply unit
for care beds in the Ecofit Xtra range

17.06.2024

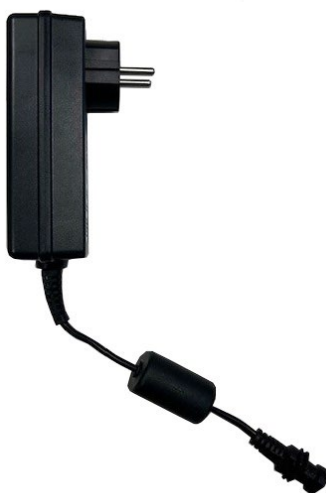
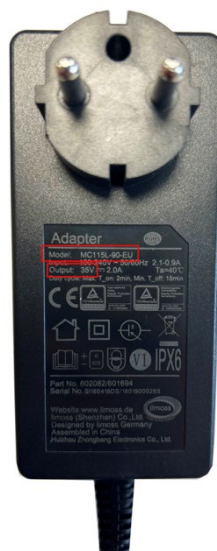
This only applies to Ecofit Xtra care beds with the built-in power supply unit **MC 115L-90-EU** (manufacturer limoss GmbH) and an output voltage of **35V**. The attached list shows the serial numbers of all products (see cover sheet) for which the power supply unit needs to be replaced.

Please replace the MC115L-90-EU power supply unit with the PS1102 power supply unit provided free of charge by tecfor care for care beds from the Ecofit Xtra range in your inventory or during the next maintenance. Instructions for replacement can be found in the appendix to this letter.

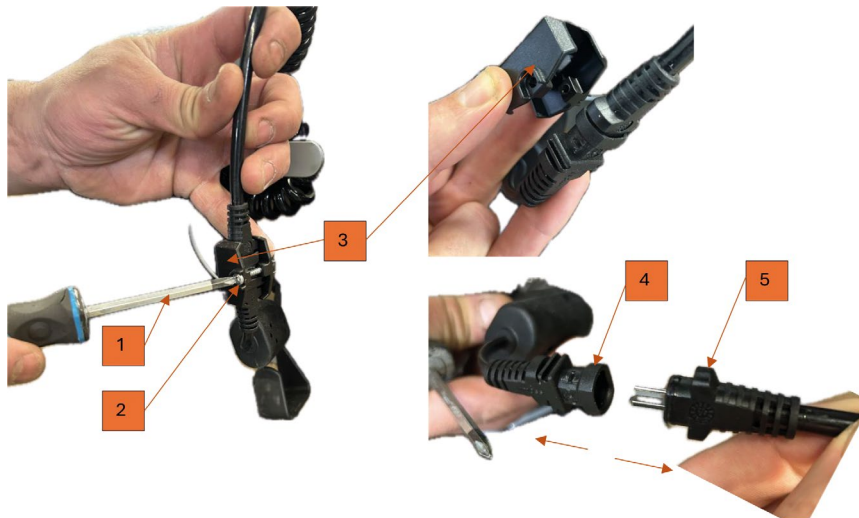
1. To remove the previously installed power supply unit, use a screwdriver (1) to loosen the screw (2) on the safety cap of the plug connection.
2. You can then remove the protective cap (3) with little effort.
3. Now release the plug connection (4+5) by pulling in the opposite direction.

1. Take the new plug from the scope of delivery and fit it in the opposite direction as described in the "Disassembly" section.
2. Once steps 3-1 have been carried out, the power supply unit is ready for use and can be reconnected to the mains supply.
