URGENT Field Safety Notice

Wired Avalon Ultrasound Transducer (product number 867246)
Inaccurate Fetal Heart Rate (FHR) measurements when monitoring multiples

22-MAY-2024

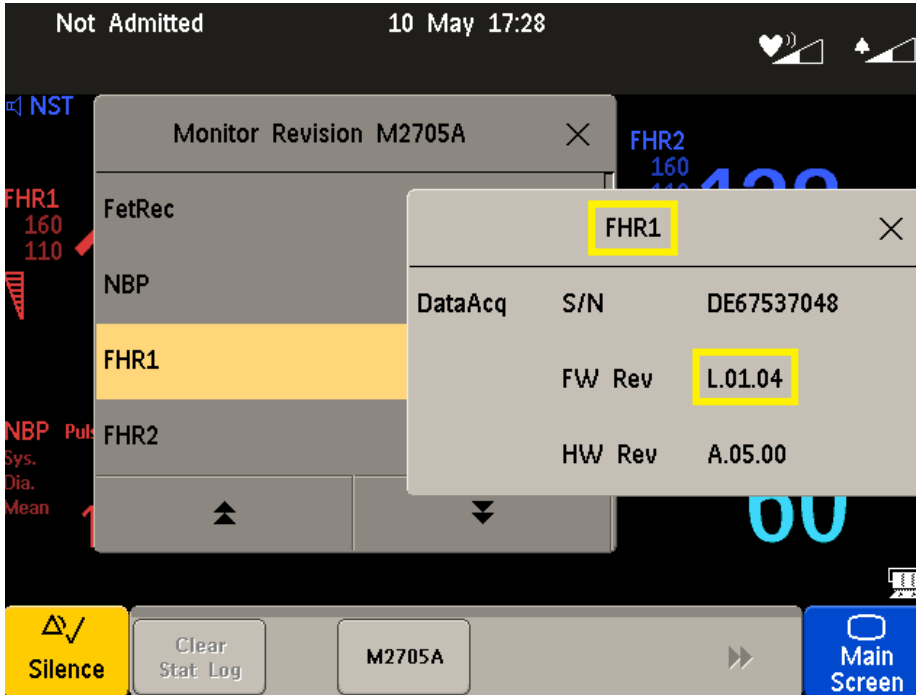
Figure 2. Checking the Transducer Software Revisions at the Avalon FM display

1. Enter the Software Revisions screen in the fetal monitor graphical user interface:
Main Setup > Revisions > [FHR to check, e.g. FHR1]

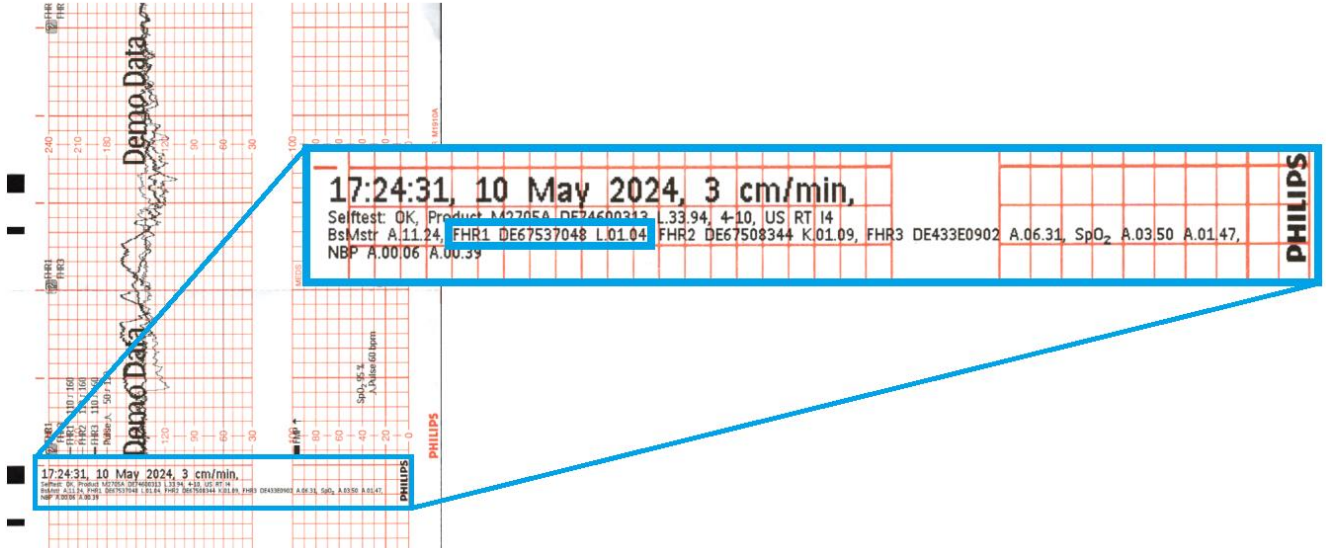
Figure 3. Checking the SW revisions of all connected transducers with the recorder header information

2. Review the recorder header of a printed trace
