Urgent Field Safety Notice (Removal)

Cordis SELUTION SLR™ 018 PTA 3.0mm X 100mm Balloon Catheters
For specific lots - See listing in Table below:

October 29, 2024

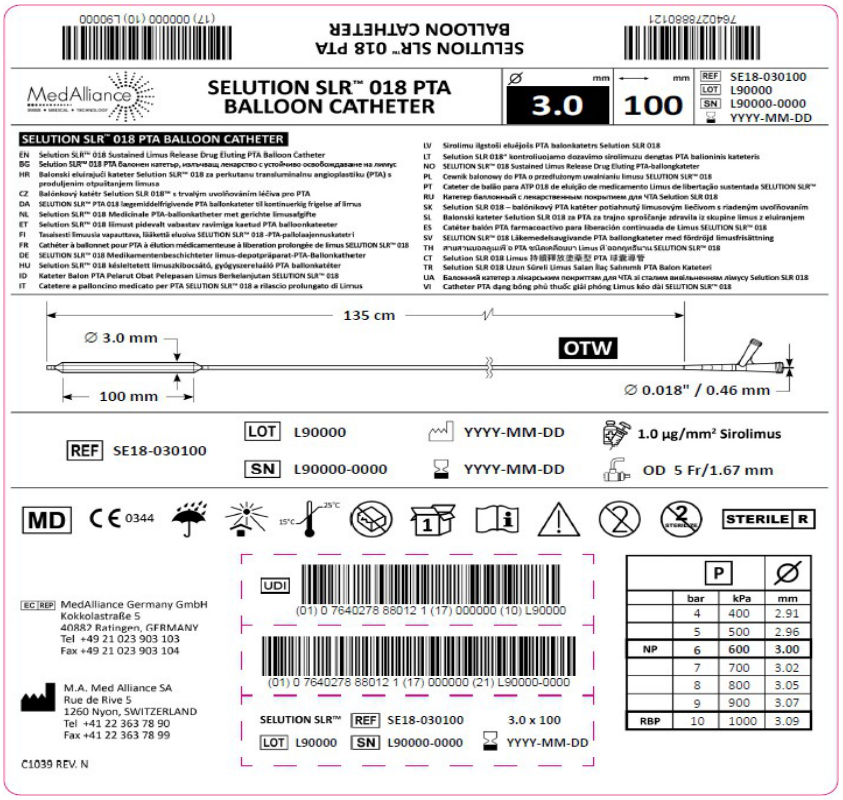
Identification:	Provided below is a sample of the box label for the affected product. This will help you identify the affected unit (s).
