URGENT FIELD SAFETY NOTICE

Material ID	Product Name	Serial Number	UDI
K10001144	FLUSHING PUMP OFP-2	22331020/22331021/22331022/ 22331023/22331024/22331026/22331027/ 22331028/22331029/22331105/22331106/ 22331544/22331545/22331782/22331783/ 22333193/22333420/22333623/22333625/ 22410060/22410061/22410062/22410246/ 22410247/22410381/22410382/22410383/ 22410471/22410472/22410570/22410571/ 22410572/22410722/22410865/22410866/ 22410867/22411712/22411713/22411714/ 22411715/22411716/22411717/22411718/ 22411719/22411720/22411721/22411723/ 22411725/22411726/22412172/22412173/ 22412184/22412185/22412186/22412187/ 22412188/22412729/22412730/22412731/ 22412732/22412733/22414265/22414266	15019778003221

Olympus is writing to inform you of a Field Safety Corrective Action pertaining to the Olympus OFP-2 Flushing Pump (“OFP-2”). The OFP-2 is a peristaltic pump intended to supply fluid to compatible Olympus endoscopes or endotherapy devices for irrigation of the gastric and colonic mucosa during endoscopic or endotherapeutic procedures, allowing improved visualization, diagnosis, and treatment. The pump can also assist in the use of transendoscopic ultrasound probes, by rapidly filling the organ to

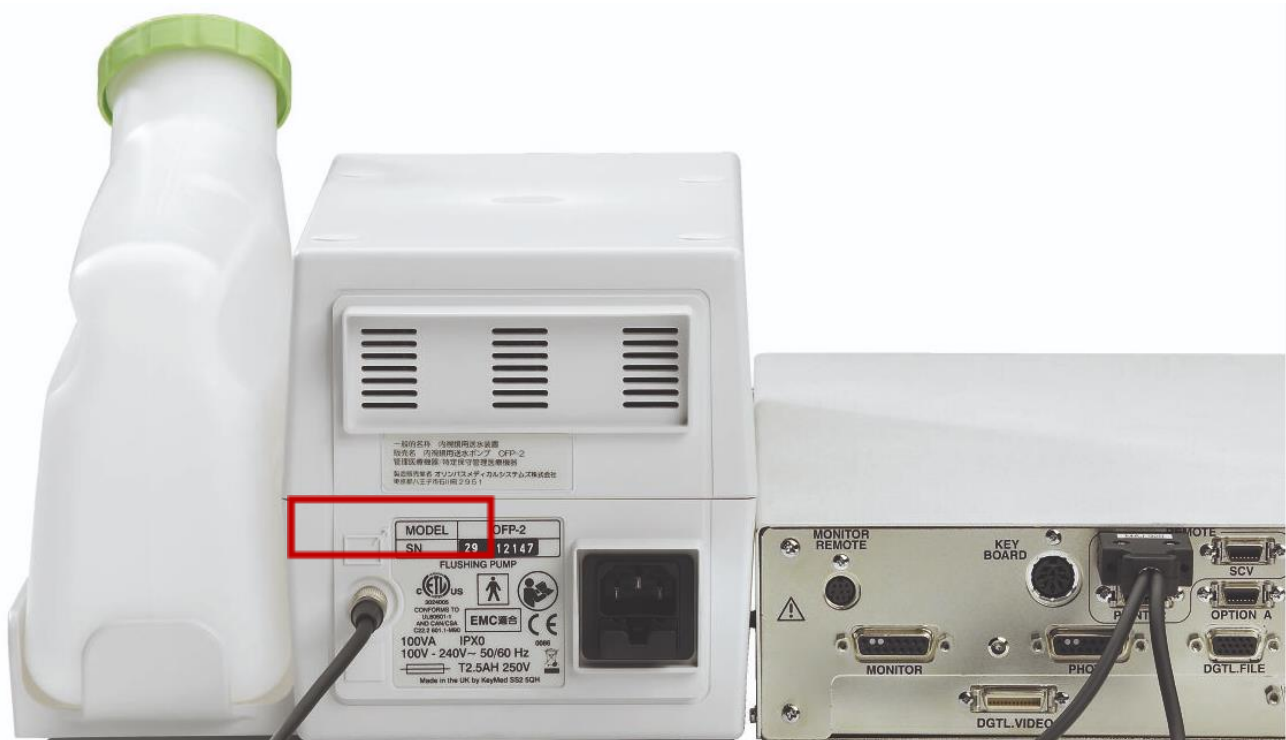
Our records indicate that your facility has purchased one or more of the affected products. The range of affected serial numbers is included at the top of this letter. The serial number is on a label affixed to the back of the OFP-2 pump. See image below.
