URGENT FIELD SAFETY NOTICE – Product Recall

Device Commercial Name:

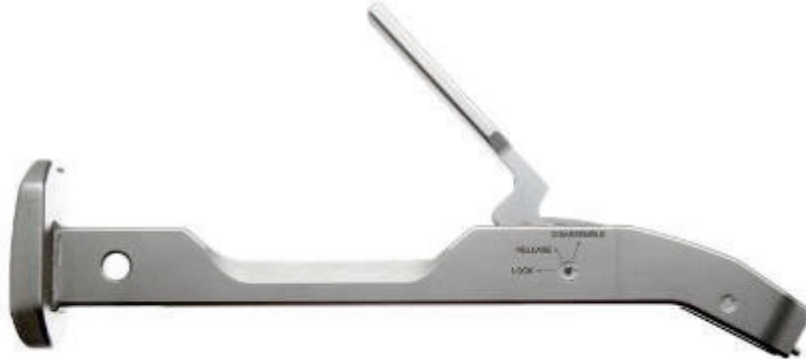
Figure 1: Universal Handle 130-394/01
